MINISTRY OF TRANSPORT

RAILWAY ACCIDENT

**Report on the Derailment and
subsequent Collision that occurred
on 18th April 1967 between Roade
Junction and Northampton**

IN THE
LONDON MIDLAND REGION
BRITISH RAILWAYS

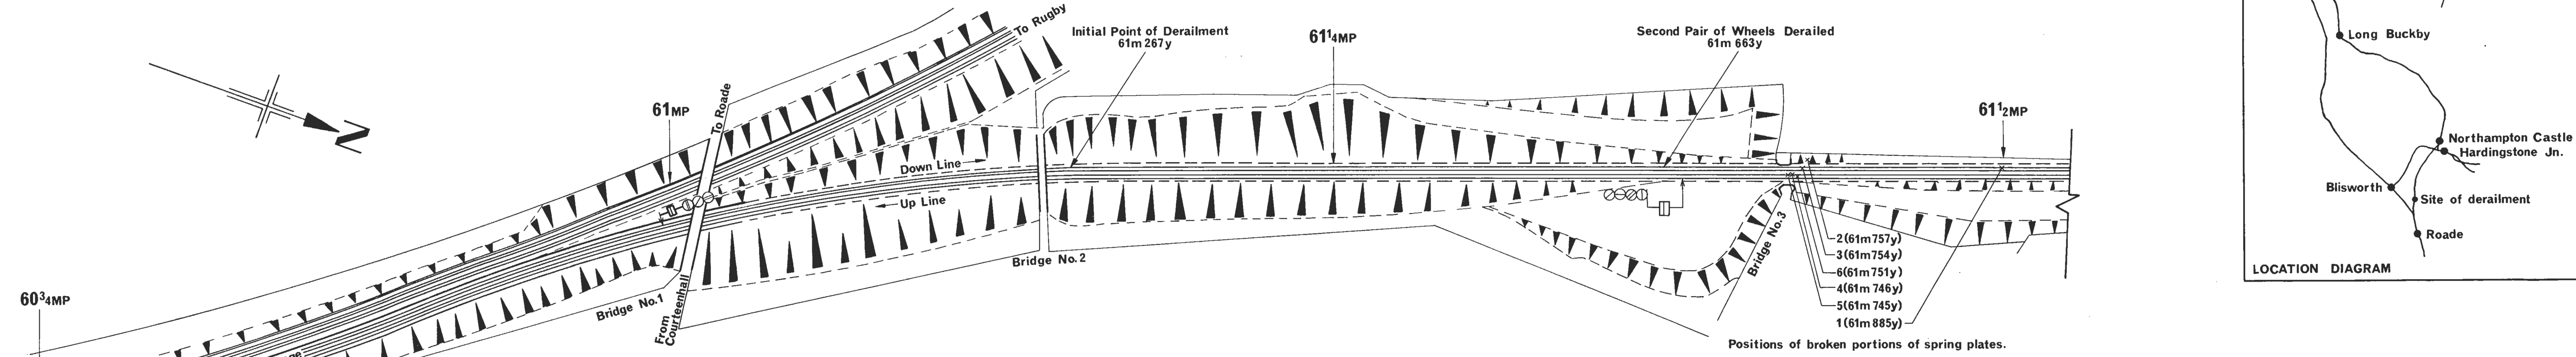
Detail of Trailing Spring on Six Foot Side of Wagon No. B.118394.

28. All six plates of the spring had broken squarely across at the rivet hole, with little unevenness in the line of the break. The two bottom plates, had been fractured over 9/10ths of their cross section area for some time to judge by the corroded fracture faces. The breakages of the top four plates were obviously new.

- (a) all the springs had been manufactured by the one firm in 1951;
- (b) the other 3 springs were well matched except that the pair to the broken spring was slightly stiffer than the other two. They were within the manufacturing tolerances for spring characteristics;
- (c) there were small fatigue cracks on the tension side at the rivet hole in about half the number of plates of the unbroken springs, not large enough to affect the spring characteristics, but making the plates more vulnerable to brittle fracture;
- (d) the four top plates of the broken spring had broken recently in a brittle manner. There were small fatigue cracks on the tension side in the fractured surfaces at the rivet hole in the top and the third plate;
- (e) all the plates of the broken spring had failed under conditions of severe overloading, the two bottom ones at some time before the others.

30. It is probable that all the plates of the spring had broken before it came apart through the bumping of the derailed wheel on the sleepers. The fact that the detached part of No. 1 plate was found 128 yards ahead of the other five would be due to the scrolled end being held by the shackle bolt of the spring shoe until it pivoted free of it. It is unlikely though that the four top plates of the spring were whole when the derailment began, and broke thereafter. It is very unusual for all the plates of a spring to break as a result of a derailment, particularly when speed is not high and the wagon is empty, and in fact the other three springs of the wagon were in good order when examined after the accident. It was possible that the spring had broken some time before the derailment, either during the journey, or shortly before it, and had been held in place by the tightness of the welded buckle. The surfaces of the fractures had not been working against each other, but the flexing of the spring after each leaf broke would have separated it from its other half fractionally, and the empty wagon might have run for some distance with the spring still held in the buckle, until it eventually worked loose. The rough treatment applied to the spring when the axle became derailed would certainly have loosened the broken plates from the buckle.

32. I am satisfied that the prime cause of this derailment was the broken spring on the 10th wagon of the goods train. I think it probable that the leading wheels of the wagon were the first to derail, the near side wheel being unweighted by the weak, defective spring above the diagonally opposite trailing wheel. When the trailing wheels in turn derailed some distance further on the snatching of the wheel under the defective spring as it bumped over the sleepers would have quickly shaken the broken plates loose from the buckle.

33. I suspect that most if not all of the top four plates of this spring had broken before the derailment and I think it likely that they had in fact broken before the journey started, for there was no specific reason for them to have broken during the journey. Impact on the wagon by grab unloading may have been the final cause of fracture of plates in a spring already weakened by the old fractures in the two broken plates and by fatigue cracks at the rivet holes in two of the other plates.

37. I accept that when the wagon was overhauled in 1965 the springs were properly examined and tested for deflection before being passed as fit for further service. The springs are not however dismembered at this examination and the test is for performance. There might therefore have been incipient fatigue cracks at that time within the buckle which would not have been detected. A significant feature of the Research Department's examination of the four springs was the number of plates with small fatigue cracks on the tension side of the rivet holes. At the time when these springs were manufactured, 1951, the design did not call for the edge of the rivet hole to be "radiused", or hot punched from the tension side, and the rivet holes in all these springs had sharp edges from which these fatigue cracks had developed. The modification for "radiusing" the rivet holes was added in July 1955 and that permitting hot punching from the tension side in September 1956. The indications are therefore that the pre-July 1955 springs, which have already had a good life in service, should be scrapped and replaced by springs of later manufacture. I understand however from Mr. Robson, the Chief Engineer (Traction and Rolling Stock) to the Railways Board, that instructions have now been issued that the springs on all unfitted mineral wagons, if manufactured more than ten years before the date that they come under notice, are to be exchanged for reconditioned or new springs, and that all springs manufactured before 1956 will be scrapped when removed from wagons at Workshop repairs or elsewhere. This programme will be facilitated by the policy to scrap wagons of this type built before 1955, which is being actively followed. These steps seem comprehensive and should certainly reduce the incidence of broken springs.

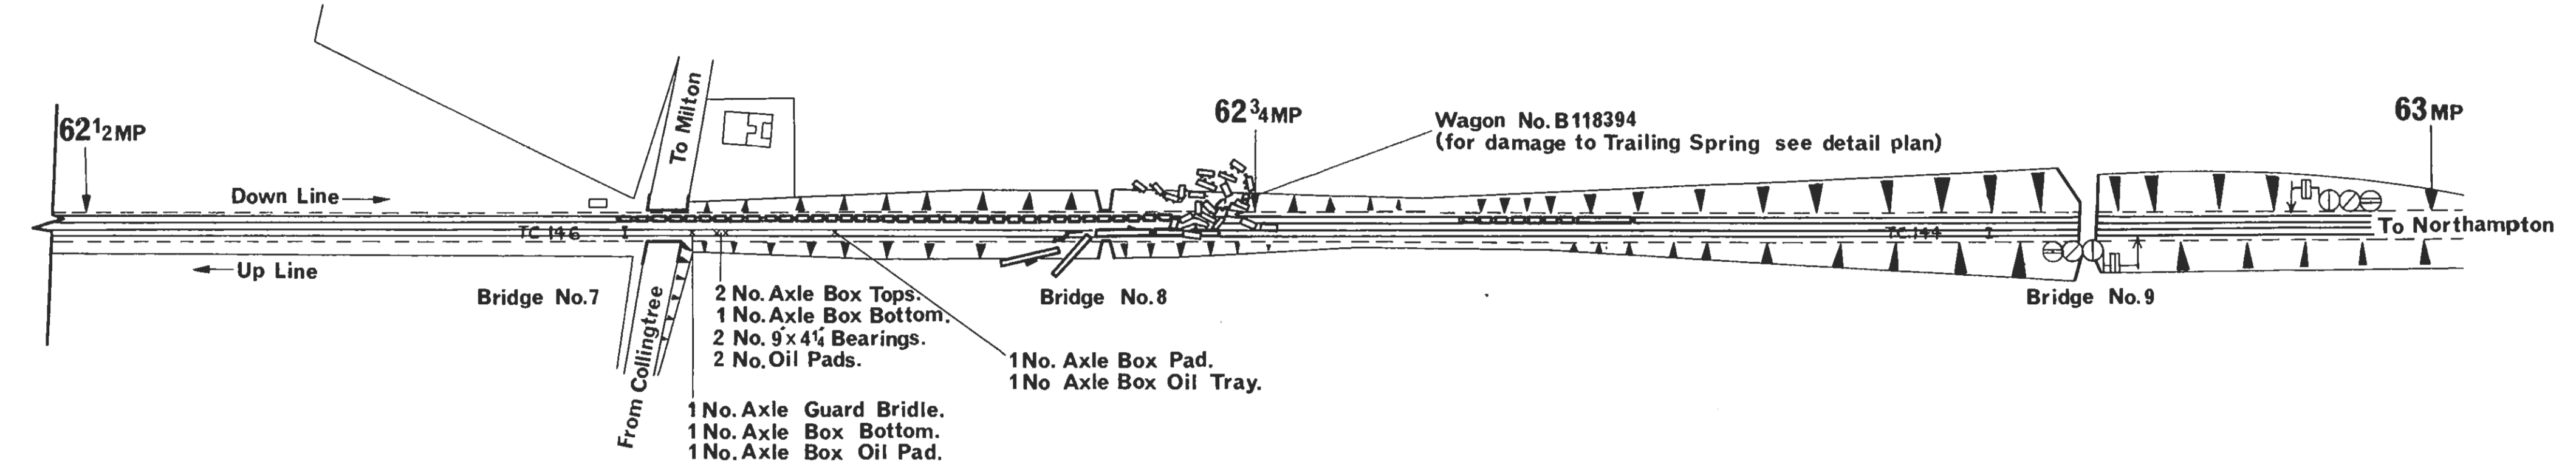
DERAILMENT AND COLLISION BETWEEN ROADE JUNCTION AND NORTHAMPTON 18-4-67

9. The position of the wrecked vehicles is illustrated on the drawing. The locomotive and 7 wagons stopped about 65 yards ahead of the wreckage, the 8th and 9th wagons were derailed but clear of the wreckage, the next 25 wagons were in a heap, partly surrounding the fourth car of the passenger train, the next 4 wagons were in line though derailed and the last 31 wagons and brake van, were on the rails. The leading car of the passenger train was lying on its left side pointing diagonally down the bank, the second car was also pointing down the bank though not on its side, and the third and fourth were more or less on the track alignment. In the front car the offside of the driver's compartment and part of the front had been stove in but not crushed against the transverse partition which was more or less intact. Though the car had turned on its side none of the interior framing had come loose and very few of the windows which were of toughened glass were broken. The interior damage to the second and third cars was light but the offside of the fourth car had suffered much more severely in side contact with a number of wagons. There was of course heavy damage to the motor bogies and power equipment of the train.

11. Three single track cantilever masts were destroyed. One, as mentioned, was by the trailing end of the crossover on the Down side and was obviously hit by a derailed wagon which the mast must in turn have deflected towards the Up line. The other two masts were in the area of collision. Approximately one half mile of overhead line equipment was brought down. Permanent way damage amounted to 8 lengths of track which required renewal, and some signalling and power cables were cut.
